POWERBOAT REPORTS

Water Repellents For Fabric

303 Fabric Guard outdoes our old favorite, Scotch Gard Heavy Duty, for about the same price. ReviveX is another top performer, but costs a lot per ounce.

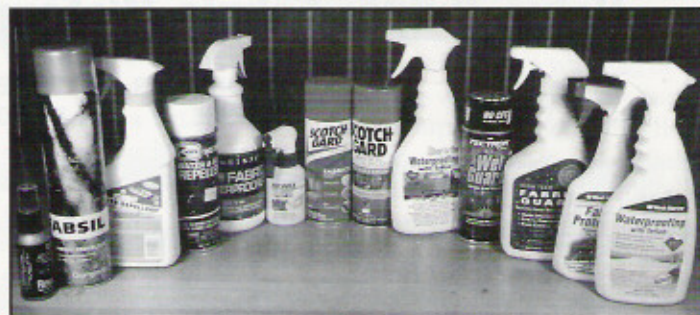
303 Fabric Guard outdoes our old favorite, Scotch Gard Heavy Duty.

The top picture shows the 13 products used in the test. The bottom photo shows 15 cotton duck 'seals,' shown attached to the clothes pins with which they were suspended for initial drying. The 'seals' were sprayed and dried (and re-coated, if recommended) exactly as specified by each manufacturer.

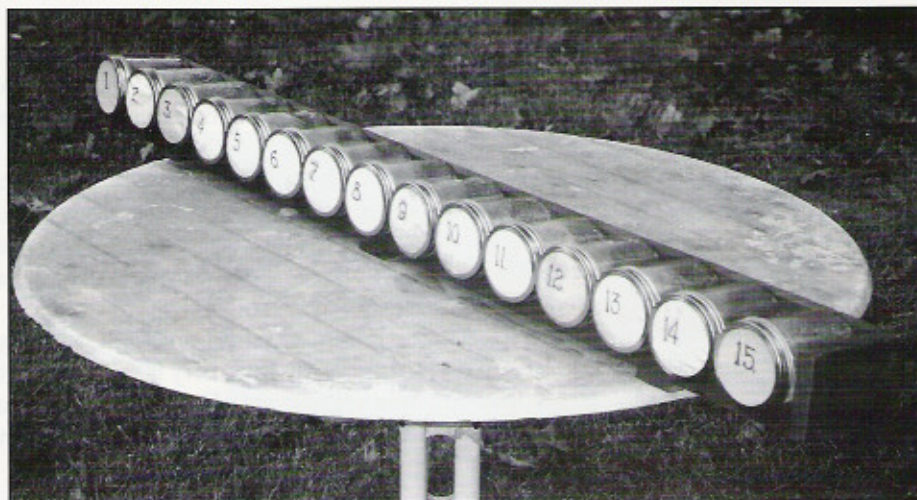
Above: Placed in a rack that holds them firmly in place, the 15 bottles, with water levels carefully noted, were placed outdoors for weathering, although this proved unnecessary.

All 15 jars, with the restored water level in each carefully marked with a permanent ink pen, then were taken outdoors and placed in a rack. The rack was made to hold them on their sides (see photo above), with half of each canvas seal in contact with the

water in each jar. The water levels in the jars were checked at one-, two-, four-, and 24-hour intervals, then again after five days. The specific results for each brand are noted on the chart.
